Manhole Inspection Summary

Manhole # S57A__002MH

Insp Date: **7/28/08 1:13 PM**

Location Address: **e fayette st**

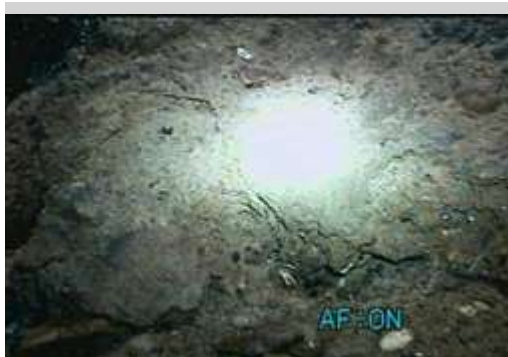
Defect 7

Misc. bench debris

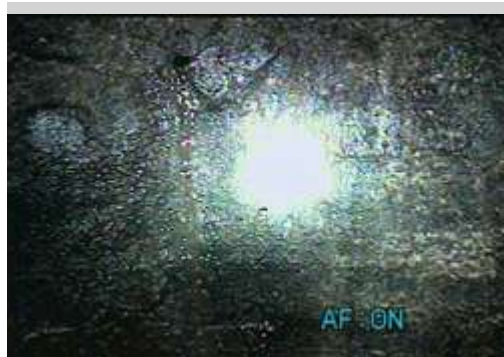
Bench debris

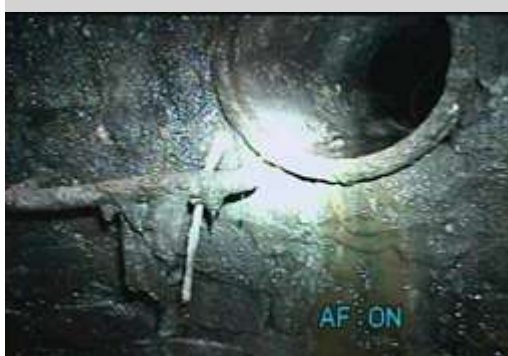
Defect 6

SURCHARGE_EVIDENCE in Barrell

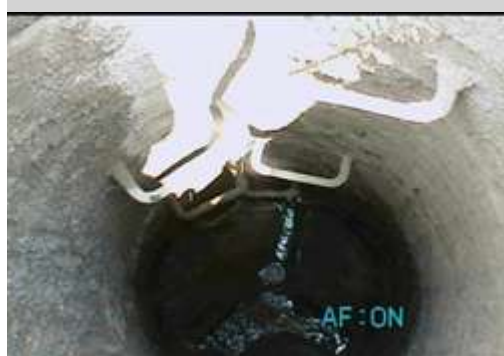
Defect 4

☒ **Corroded**

steps

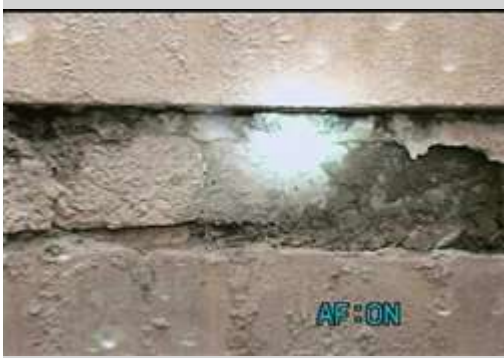
Defect 3

☒ **Loose Brick**

☒ **Deteriorated**

CHIMNEY_COND_LOOSE_BRICKS ,
CHIMNEY_COND_DETERIORATED

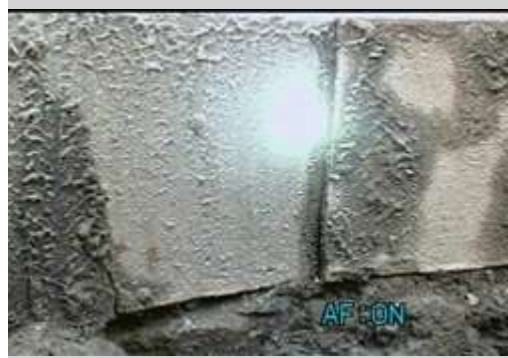
Defect 2

☒ **Cracked**

☒ **Leaks**

frame cracked and leaks

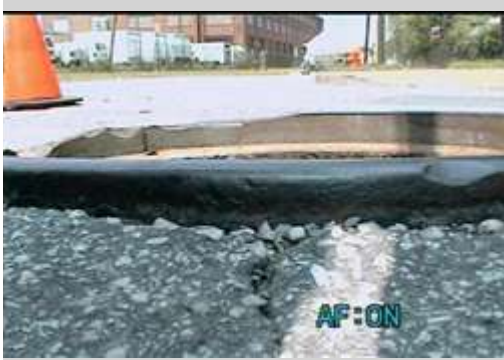
Defect 1

above grade
